[Docket No. FAA-2020-0455; Product Identifier 2019-SW-105-AD; Amendment 39-21130; AD 2020-11-05]

Airworthiness Directives; Airbus Helicopters

SUMMARY: The FAA is adopting a new airworthiness directive (AD) for all Airbus Helicopters Model EC120B helicopters. This AD was prompted by a report of recurrent loss of tightening torque on several attachment bolts of the tail rotor hub body. This AD requires repetitive inspections of the tail rotor hub body for cracks and applicable corrective actions if necessary, and repetitive replacement of the attachment bolts, washers, and nuts of the tail rotor hub body. The FAA is issuing this AD to address the unsafe condition on these products.

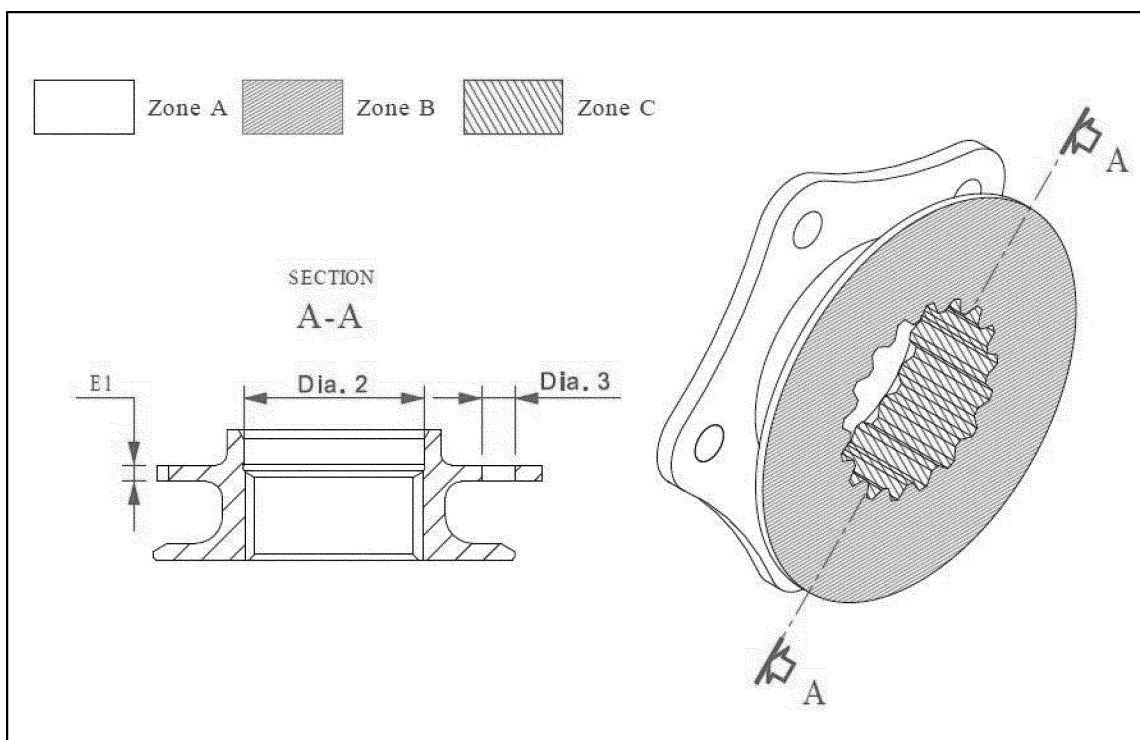
**Figure 2 to paragraph (i)(1) – Inspection Areas of Tail Rotor Splined Flange**

Location as specified in figure 2 to paragraph (i)(1) of this AD	Maximum damage, which causes replacement (E1, Dia. 2, and Dia. 3 are shown in figure 2 to paragraph (i)(1) of this AD)
Zone A	Score, depth more than 0.2 millimeters (mm) (0.008 in.) Crack E1 less than 2.75 mm (0.108 in.) Dia. 3 more than 6.02 mm (0.2371 in.) Dia. 2 more than 33.03 mm (1.3004 in.)
Zone B	Sanding depth more than 0.1 mm (0.004 in.) Crack
Zone C	Crack Score, depth more than 0.2 mm (0.008 in.)

(2) If, during any inspection of the tail rotor splined flange required by paragraph (i)(1) of this AD, the condition of the part exceeds the criteria as specified in figure 1 to paragraph (i)(1) of this AD, before next flight, replace the tail rotor splined flange with an

airworthy tail rotor splined flange in accordance with the instructions of section 3.B.4 of Airbus Helicopters Emergency Alert Service Bulletin 05A020, Revision 1, dated November 8, 2019.
