# What is the impact and cost of a diesel spillage?

April 2019

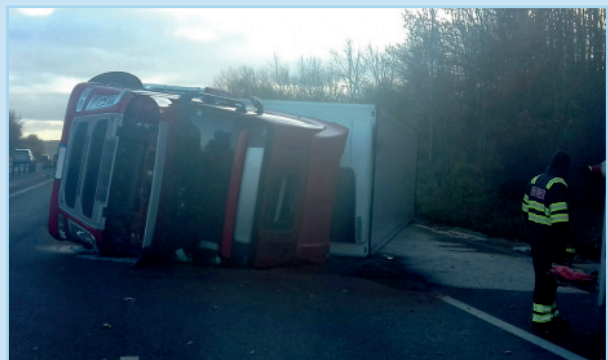
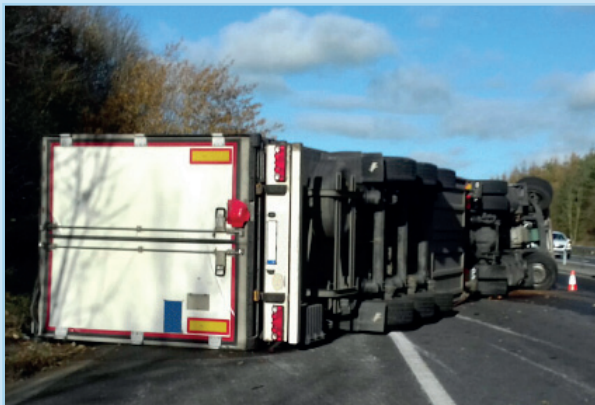
On the 25th November 2017 at approximately 11.15am an articulated HGV was travelling northbound along the M11 when the driver swerved to avoid another vehicle. This action led to the HGV ending up on its side. This caused the diesel tank to rupture and leak 500 litres of diesel onto the road surface.

The emergency services were first to the scene and put a road block in place across 2 lanes of the motorway as the HGV had come to rest blocking the hard shoulder and lane 1.

Despite delays in treating the spillage the MSP was able to use a spillage kit and neutralise the diesel spill. On this occasion the weather slowed down the corrosion of the road surface from the diesel spillage. A combination of the sand and the freezing temperature stopped the diesel spillage soaking into the asphalt.

The cost of this particular spillage was relatively low in comparison to others in this document. This is mainly due to the road surface not needing to be relayed immediately; although due to the size of the spillage and the necessary scene management, there were long delays which held up motorway users for 13 hours 15 minutes.

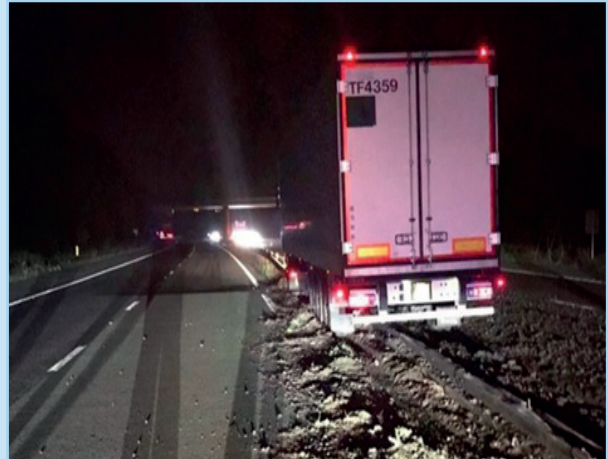
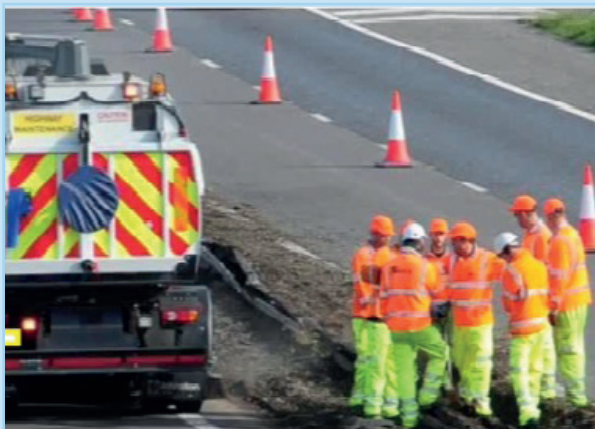
On the 7th September 2017 at approximately 04:00 an articulated HGV was travelling southbound along the M11 near to junction 12, when the HGV hit the central reservation demolishing both protective barriers on the southbound and the northbound carriageways.

The impact resulted in a puncture to the HGV's fuel tank leaking 400 litres of diesel onto the southbound carriageway.

The emergency services and the MSP had put in place traffic management, directing traffic using the "Up and Over" method of diverting the traffic up and back down the slip roads to avoid the accident.

The extra resource was needed to deal with contaminated soil, which contributed to a large proportion of the cost of the recovery. Contaminated soil in the central reservation area had to be replaced where the truck had pierced its fuel tank, despite a spillage kit being put to good use to treat the diesel on the road surface.

In this case the SITREP was used to good effect, as all parties worked well together formulating a plan quickly to stop the M11 coming to a complete standstill. Although there were delays, a diversion was put in place quickly. The HGV was recovered in a timely manner and the diesel spillage could be dealt with.

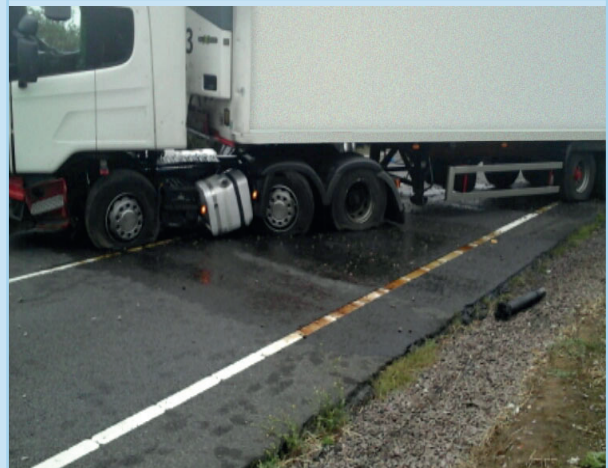
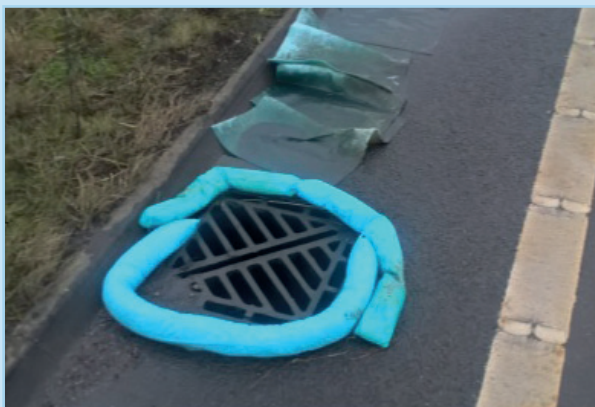
On the 18th September 2016 at approximately 06:00 an articulated HGV was travelling westbound along the A14 near to junction 13. The driver lost control of the vehicle due to a burst tyre and was unable to stop the HGV before colliding with the central reservation.

When the vehicle collided with the central reservation the vehicle overturned, rupturing the fuel tank leading to a complete fuel system failure. The subsequent failure resulted in a diesel spillage stretching 200 metres along the carriageway. The diesel was prevented from entering the water ways by the use of mats and booms.

The initial spillage was so severe that the damage to the road surface was irrecoverable and resurfacing was the only option. This then caused long delays and a cost of £541,440 to the UK economy.

Although there were road closures on a large part of the SRN, it was necessary as the risk to other road users (as per the SITREP analysis) was deemed to be high. The return to normality works were carried out with additional resource brought in to hurry the resurfacing and clean-up of the diesel spillage.

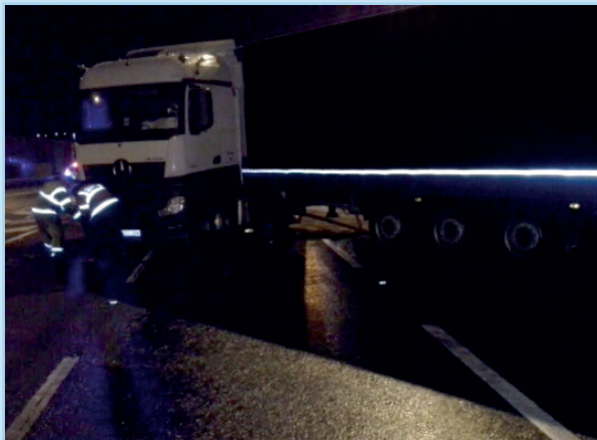
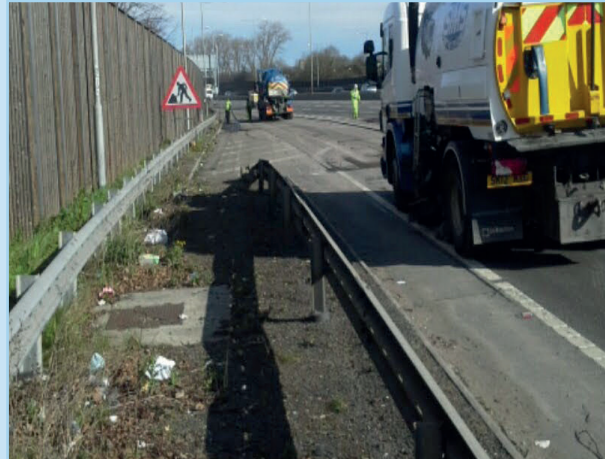
On the 1st April 2016 at approximately 21:14 an articulated HGV was travelling northbound on the M1 near to junction 11. The HGV driver swerved to avoid hitting another vehicle which resulted in the HGV jack-knifing across all lanes of the M1 northbound.

A passenger vehicle travelling behind the HGV could not stop in time resulting in a collision with the HGV's fuel tank causing diesel to spill out across the carriageway. There was also some fuel leakage from the passenger vehicle that was wedged under the HGV.

There was a need to involve the Environment Agency as the diesel spillage had entered into the water course. The cost of the spill was large, due to the amount of extra resource and specialist equipment needed to clear the diesel spillage and for the road to be resurfaced.

To reduce the impact of the incident, traffic management was set up along with a full diversion around junction 11. This was to aid the speed of the recovery of the vehicle and treatment of the spillage. There were diversions in place for nearly 18 hours with the cost of the incident to the UK economy being an estimated £1,488,960.
